Meizu MX6 Teardown

Teardown of the Meizu MX6 on Monday July 25th 2016.

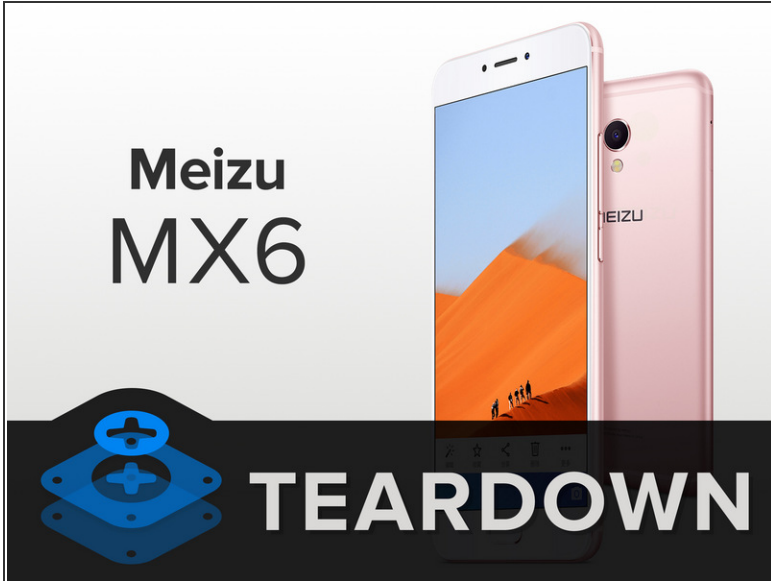
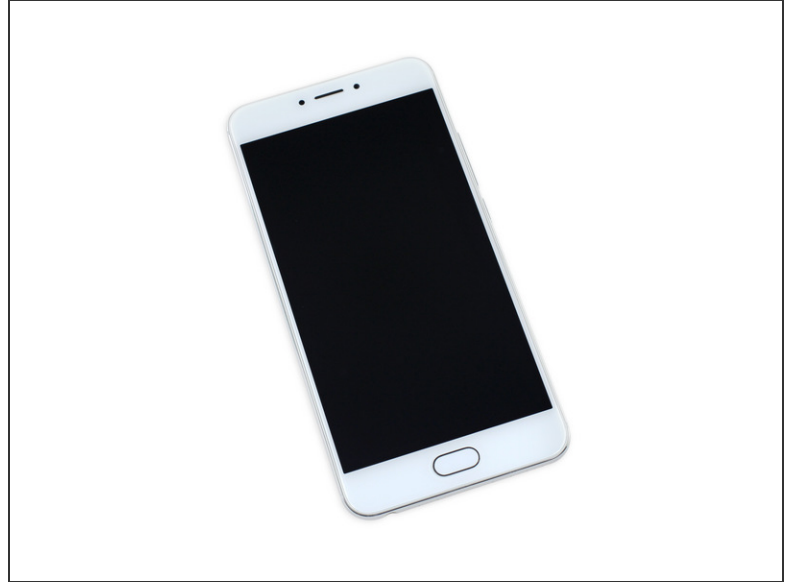
Step 1 — Meizu MX6 Teardown

- On the outside, the MX6 walks the iPhone walk, but does it talk the talk? Here's what we know so far:
 - MediaTek Helio X20 deca-core (a.k.a. *10 cores!*) CPU w/ ARM Mali-T880 GPU
 - 4 GB LPDDR3 RAM and 32 GB of storage
 - 5.5-inch, 1080p high-precision display (~401 ppi)
 - 12 MP *f*/2.0 main camera w/ 1.25 μm pixels and 5 MP front-facing camera
 - Flyme OS 5.2 over Android 6.0 Marshmallow
 - 3,060 mAh battery with 24 W fast charging
 - USB-C port, Dual SIM support, and Meizu mTouch fingerprint sensor

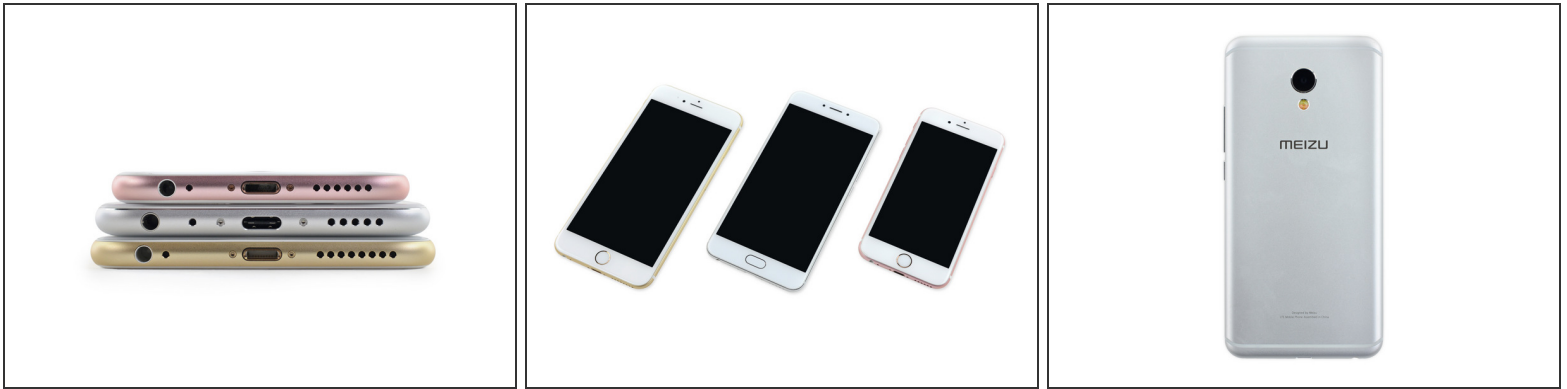
Step 2

- It's a three-phone pile-up as we pull over to take a cursory look at how the MX6 compares to its iPhone idols.
- A quick comparison reveals...not a whole lot. Apart from the USB-C connector and a slightly shifted microphone port, we're hard pressed to distinguish the MX6 from its Cupertino-based counterparts.
- It's a similar story topside. Aside from the oval home button and different side button configuration, the MX6 fits right into the iPhone lineup—what with its metal unibody design and [2.5D glass panel](#).
- The MX6 differentiates itself with a centered rear camera and dual flash assembly, but those subtle antenna bands are reminiscent of [certain iPhone 7 rumors](#).

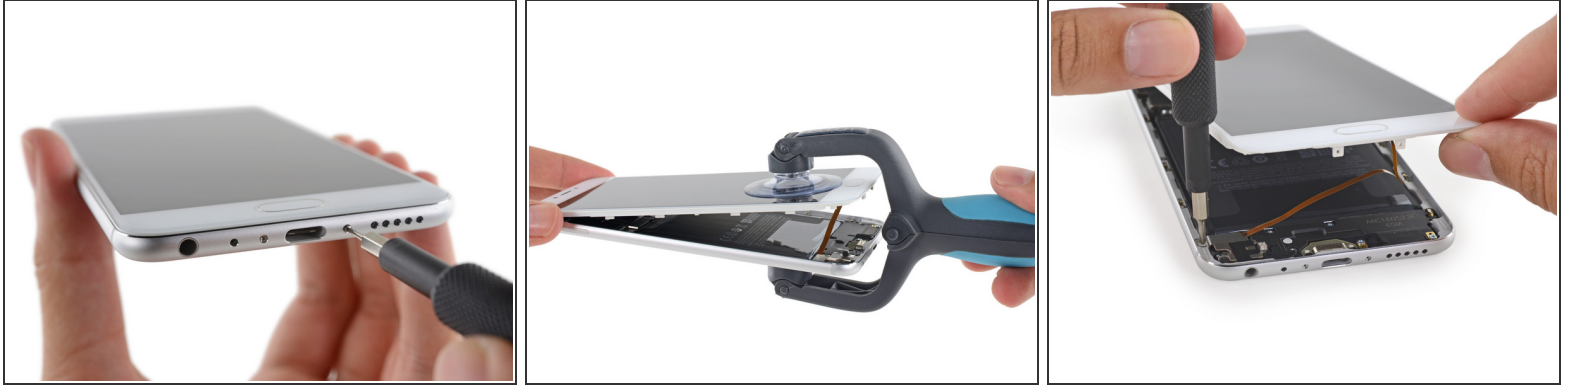
Step 3

- Like the [Huawei P9](#), the MX6 seems inspired by the iPhone in more than just looks: two Pentalobe screws secure the MX6's display assembly to the chassis.
- We're still baffled as to why manufacturers would copy Apple's screw design, when a regular ol' Phillips or Torx screw does the same job better with less hassle.

*Ruh Roh, Raggy!* We also find a [fingerprint reader cable booby trap](#) like in the iPhone 5s/SE!

- Not to worry, Scooby Doo— Meizu cut us some slack (literally), so the cable is unlikely to rip when opening the phone.
- ① The cable's connector lies under a screwed-down, tamper-evident bracket that's arguably simpler than Apple's [awful spring clip](#).

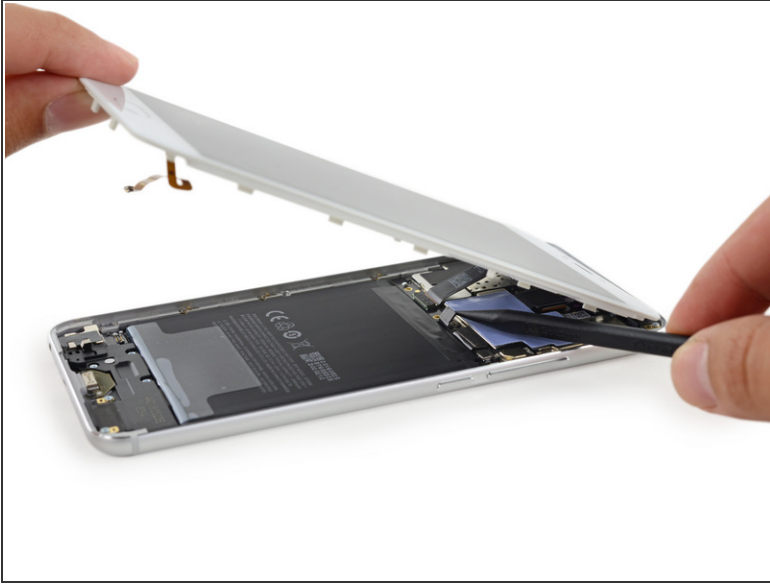
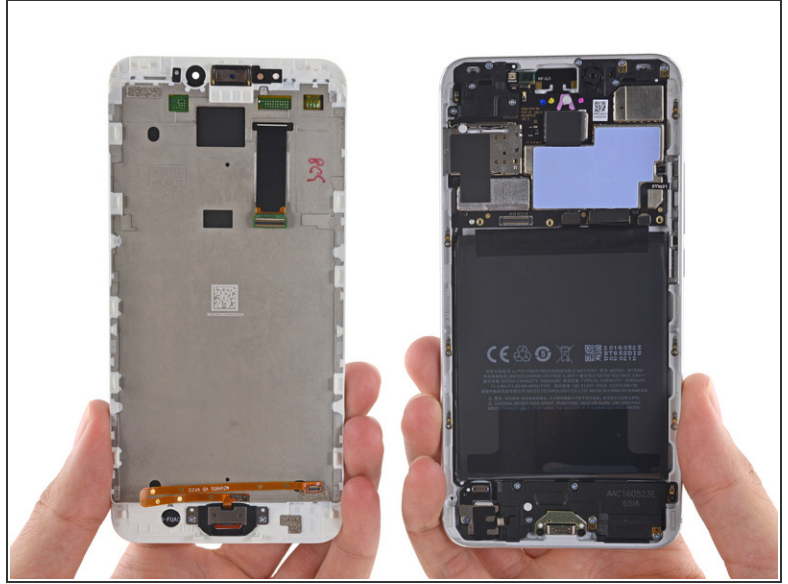
Step 4

- Before diving in, we pause to disconnect the battery; its small connector releases with a flip of the spudger. [Safety first.](#)
- With the MX6 safely de-electrified, we pop the display cable free and peer inside.
 - First observation: *Phillips screws— everywhere!* A small celebration breaks out around the teardown table.
 - Second observation: Looks like the iPhone mold is mostly skin-deep, look at that big ol' battery. *!We just can't wait to dig in.*

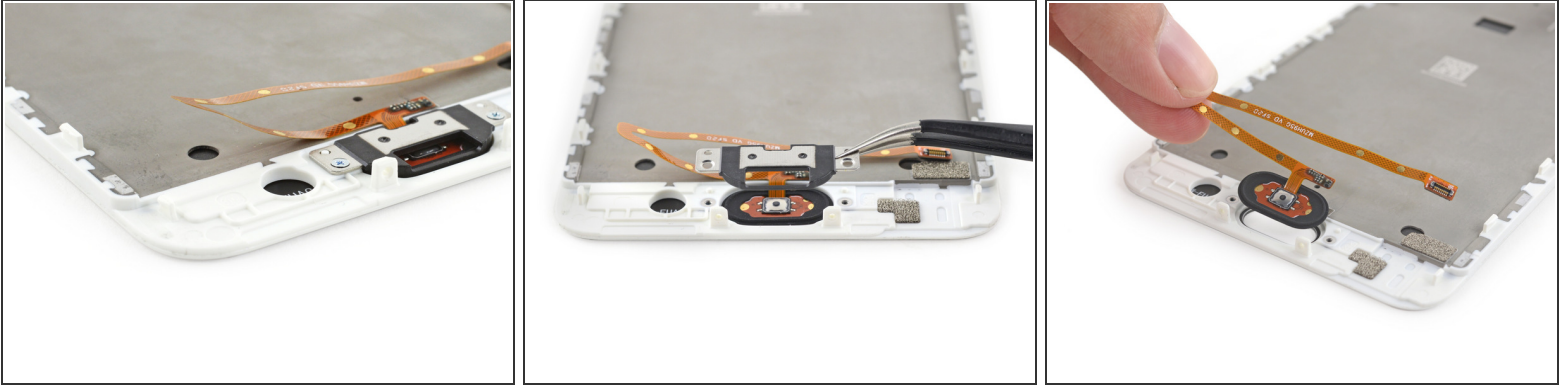
Step 5

- Interestingly, the display's perimeter is all plastic, including its clips and edges. This may be a durability concern, but there's no risk of [display bracket separation](#).
 - Out comes the bracket securing the fingerprint sensor—followed by the sensor itself, with its long [switchback](#) cable in tow.
- ⓘ This display assembly is a much simpler affair than you'll find in a comparable iPhone (or Android phone!), thanks to some handy spring contacts and a motherboard-mounted front-facing camera.
- ★ That means a cheaper, simpler repair!

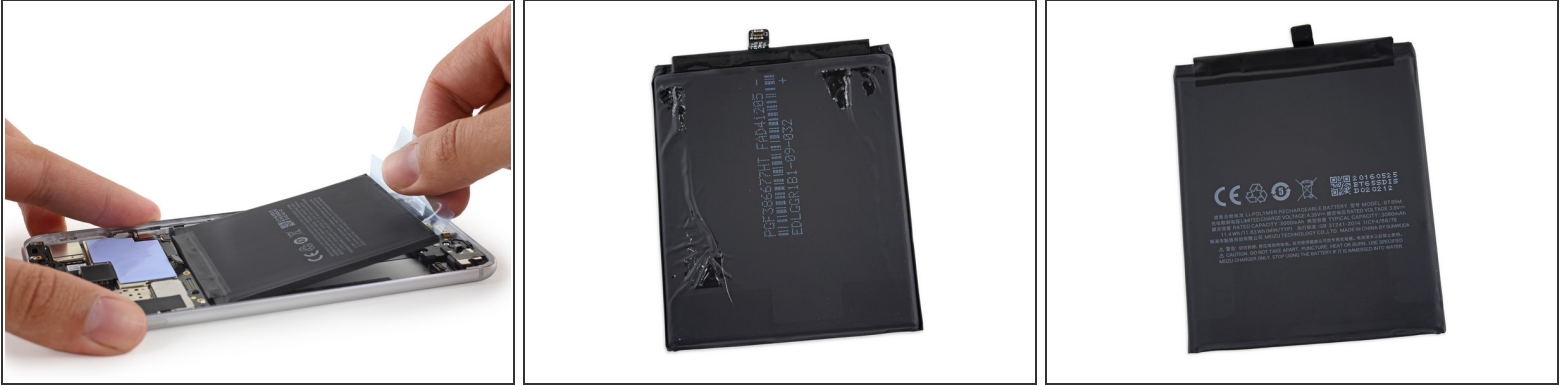
Step 6

- With the display assembly out of the way, we carefully excavate the MX6's stubbornly-adhered battery. Luckily, the battery features an [iPhone 4-esque battery pull tab](#) that makes the job a bit easier.
- The MX6 packs a non-user-removable, 3.8 V, 11.63 Wh Li-poly battery.
 - ⓘ This puts the MX6's battery ahead in the power struggle, topping the [iPhone 6s Plus](#)'s 10.45 Wh battery, and just barely surpassing the [Samsung Galaxy S7](#)'s 11.55 Wh battery.
 - ⓘ Meizu claims that their mCharge 24 W (12 V at 2 A) fast charging technology will fully charge the MX6's battery in only 75 minutes, compared to [90 minutes](#) for the Galaxy S7.

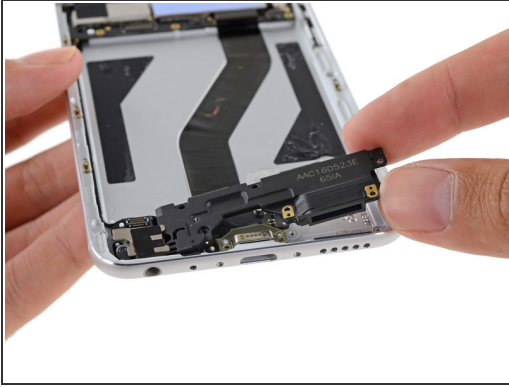
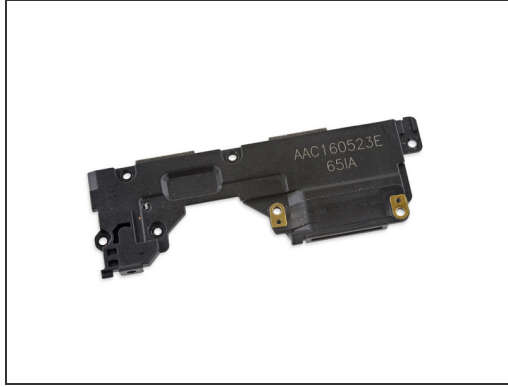
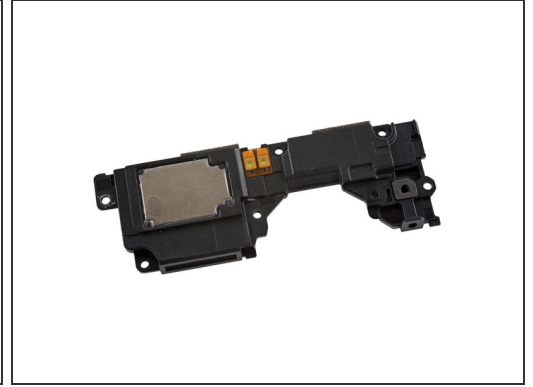
Step 7

- Next to come out? The speaker assembly, complete with spring contacts and what appears to be an antenna sticker of some kind.
- Part of the assembly lines up with the lower microphone hole—but if you go looking for a mic here, you'll be disappointed!
- This assembly has a tiny acoustic tube channel with a 90-degree bend, passing sound from the outside world to a mic located elsewhere...

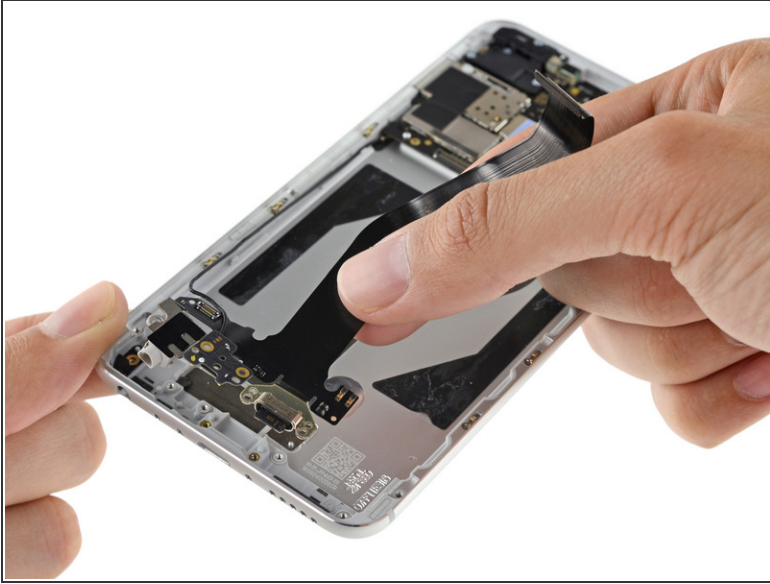
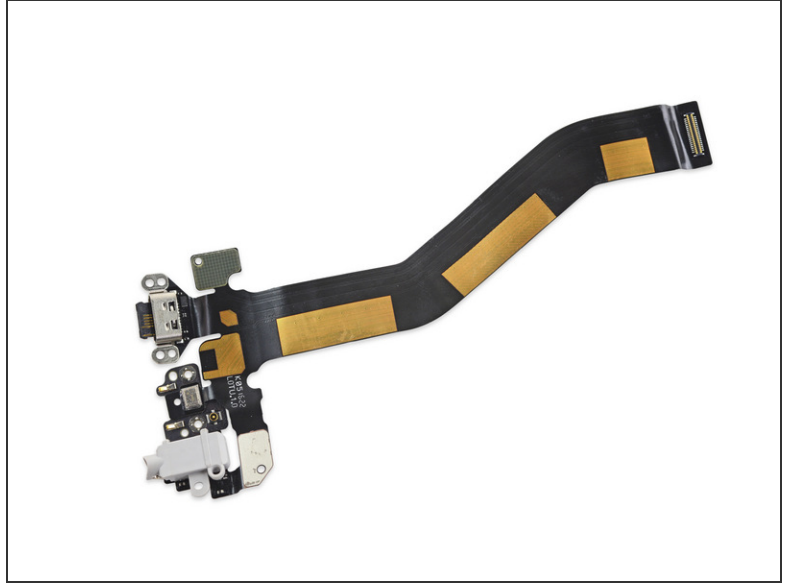
Step 8

- "Elsewhere" turns out to be a combined USB-C, headphone jack, and microphone assembly—which we dutifully peel out of the chassis of the MX6.
 - ⓘ A small amount of adhesive secures the cable to the chassis, but it presents no problem for our teardown engineer.
- Upon inspection, we find antenna connections on the bottom of the cable, as well as on the bottom of the motherboard.
- ☑ Manufacturers seem to be in competition to cram [as much](#) as they [possibly can](#) onto the charging port cable. (Which means a pricier repair when your port eventually gets loose.)

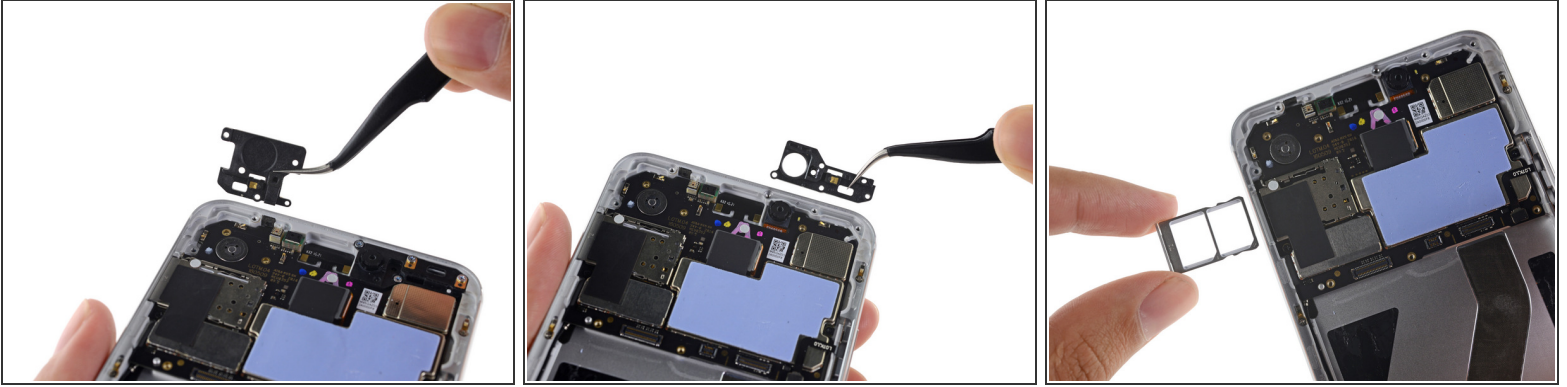
Step 9

- With tweezers in hand, we deftly pluck out several bits 'n pieces:

- Antenna/vibrator bracket
- Antenna/front-facing camera bracket
- Dual SIM card tray
- [Turbo-encabulator](#)

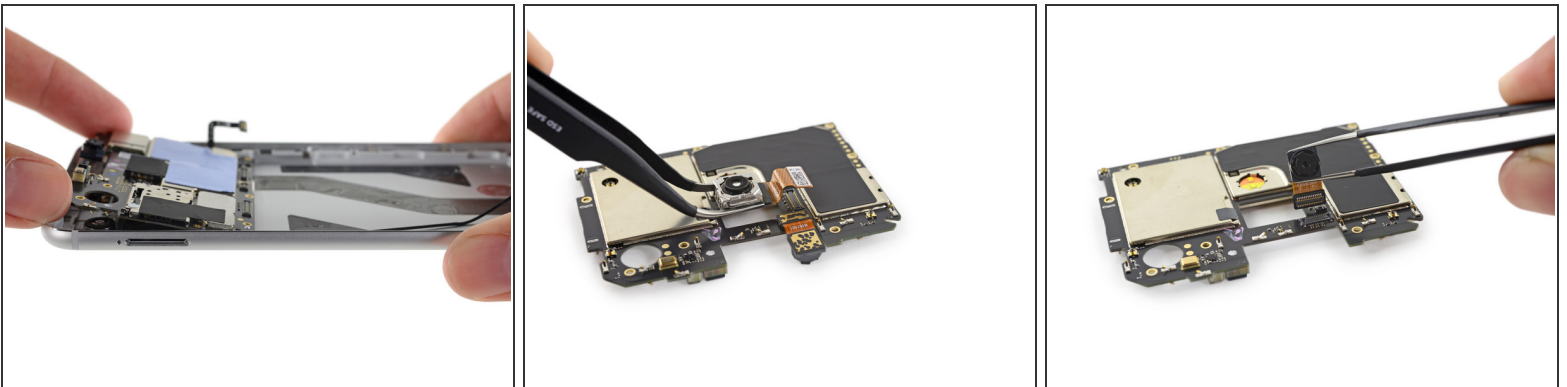
Step 10

- With those bits out of the way, we lift the motherboard out and get a closer look at the cameras.

The rear-facing camera features Sony's 12 MP [Exmor RS IMX386](#) CMOS image sensor along with a 6-element $f/2.0$ lens, while the front-facing camera features a 5 MP sensor with a 4-element $f/2.0$ lens.

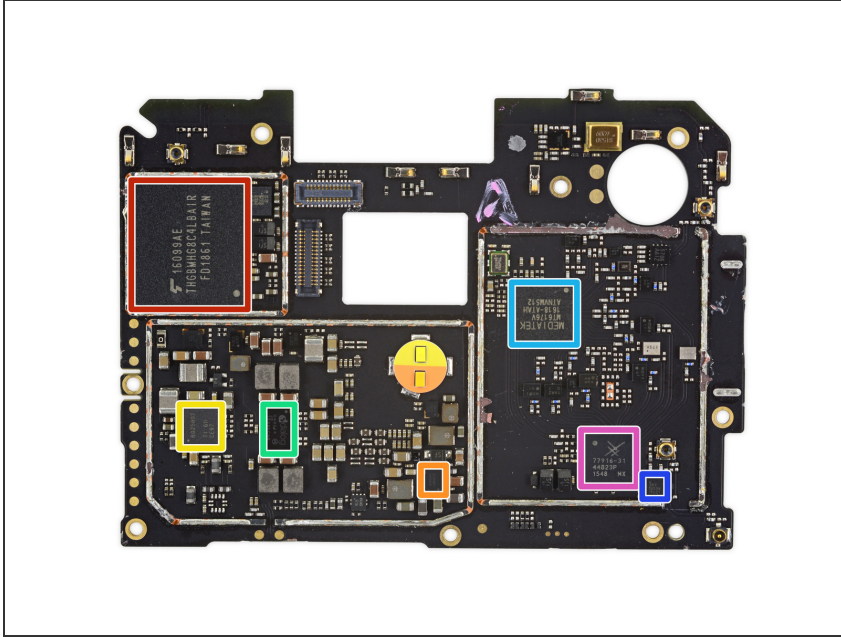
Step 12

- On the flip side:
 - Toshiba [THGBMHG8C4LBAIR](#) 32 GB eMMC 5.1 NAND Flash
 - Texas Instruments [LM36272](#) LCD Backlight Driver
 - Texas Instruments [BQ25892](#) Fast Charging IC
 - Dialog Semiconductor [DA9214](#) PMIC
 - MediaTek [MT6176V](#) RF Transceiver
 - Skyworks [SKY13596-397LF](#) RF Switch
 - Skyworks [SKY77916-31](#) RF PAM

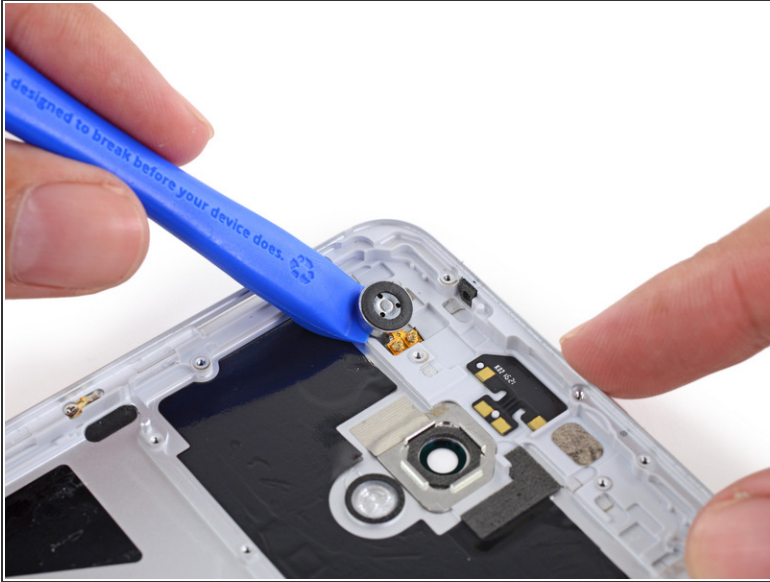
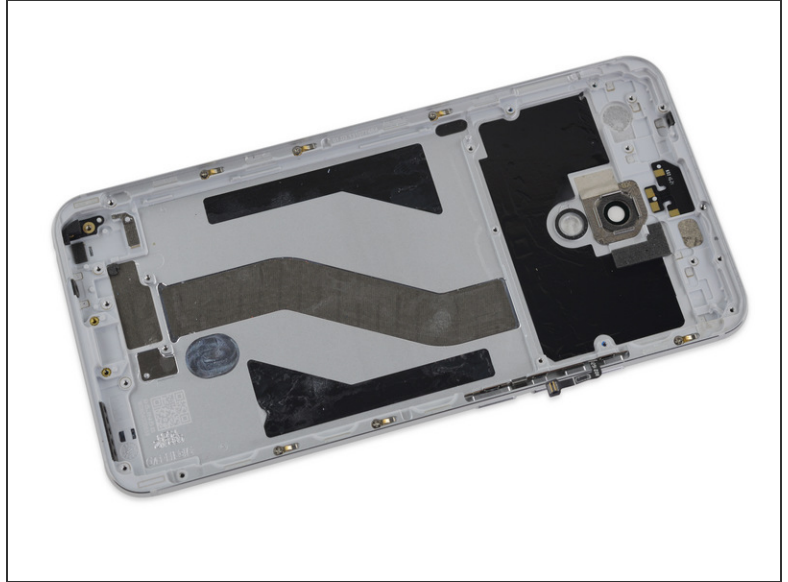
Step 13

- The final few pickings come from the MX6's chassis.
- We pry out the (tiny!) rotational vibrator motor. It's different from the linear oscillating motors and "Taptic Engines" used in many ([not all](#)) iPhone models, but also takes less space.
- The chassis itself is peppered with spring contacts, which no doubt made our teardown journey that much easier.

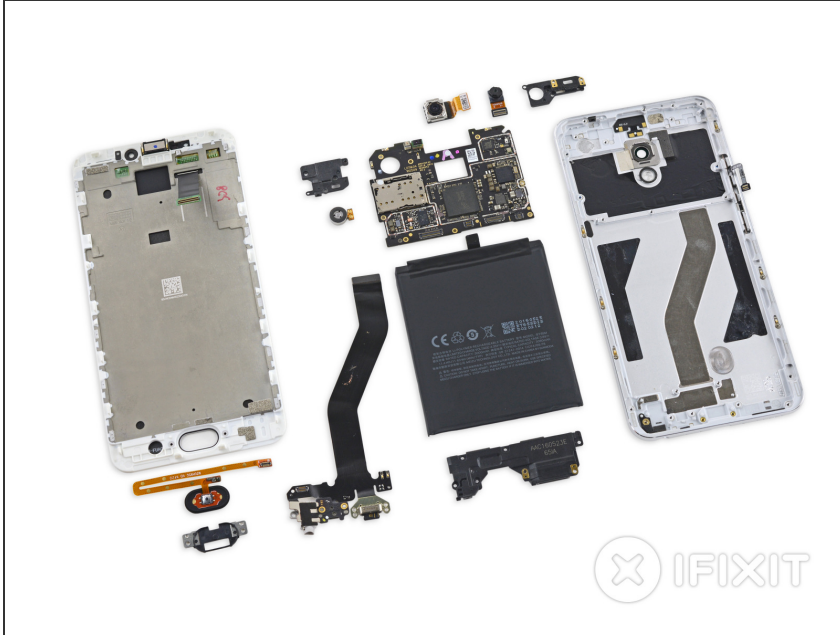
Step 14

- Though the exterior design looks undeniably iPhone-esque, the hardware layout calls to mind [another recent Android hit from China](#).
- And that's a wrap! Time to give this phone a score.
